**Flood Control Project Maintenance
Levee Inspections**

Fall 2015 Levee Maintenance Deficiency Summary Report

California Department of Fish and Game Shea Levee

Levee Inspection Report By Mile - Fall 2015

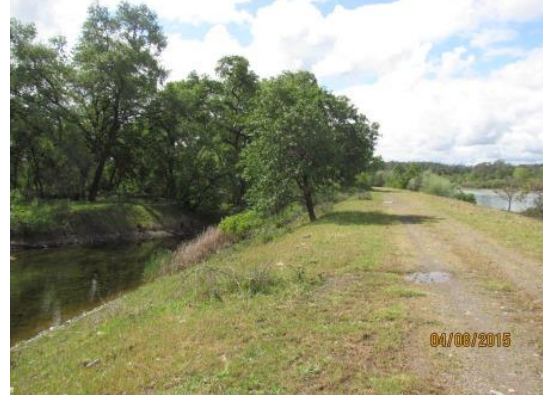
Photo 1 of 2 : FA_2015_NA0018_269_2_20150910_00002.jpg

LM Start	0.00	Rating **	M	Issue No.	2
LM End	0.07	Issue Type +	Ma	Location *	LS
Category	Earthen Levee			GPS Latitude/Longitude	
				Start	End
Item	Vegetation			40.508138 °	40.508138 °
				-122.363480 °	-122.363480 °
DWR ID	DWR_NA0018_01_s _ 2012_2				
Action/Comments					
Remove the wild growth other than native grasses from the levee slopes. Inspector Comments: California Department of Fish and Wildlife has not completed any maintenance this year.

View of the levee with no maintenance done.

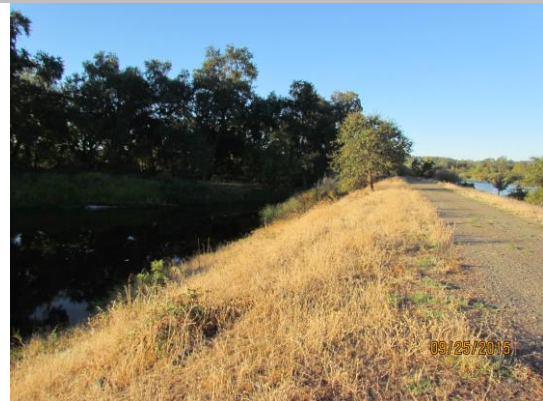
Photo 2 of 2 : FA_2015_NA0018_269_2_20151012_00006.jpg

LM Start	0.00	Rating **	M	Issue No.	2 (cont)
LM End	0.07	Issue Type +	Ma	Location *	LS

View of the levee with no maintenance done.

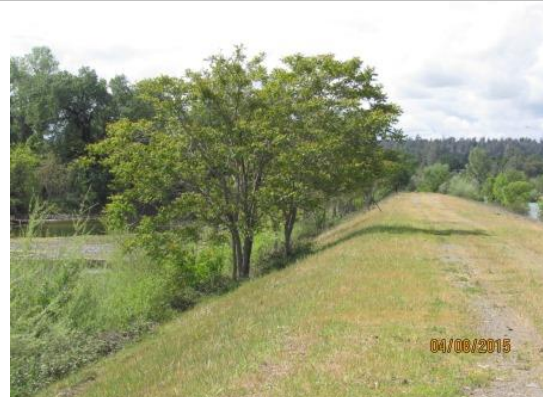
Photo 1 of 2 : FA_2015_NA0018_269_9_20150910_00005.jpg

LM Start	0.00	Rating **	M	Issue No.	9
LM End	0.21	Issue Type +	Ma	Location *	LS
Category	Earthen Levee			GPS Latitude/Longitude	
				Start	End
Item	Trim / Thin Trees			40.509012 °	40.510649 °
				-122.362609 °	-122.360945 °
DWR ID	DWR_NA0018_01_f _ 2012_9				
Action/Comments					
Thin trees to allow visibility of the ground and room to flood fight. Inspector Comments: Fish and Wildlife Service has not completed any maintenance.

Remove the small trees along the landside slope.

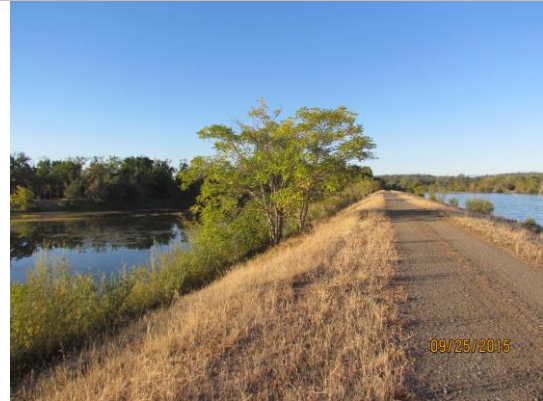
Photo 2 of 2 : FA_2015_NA0018_269_9_20151012_00007.jpg

LM Start	0.00	Rating **	M	Issue No.	9 (cont)	
LM End	0.21	Issue Type +	Ma	Location *	LS	
Category	Earthen Levee			GPS Latitude/Longitude		
				Start	End	
Item	Trim / Thin Trees			40.509012 °	40.510649 °	
				-122.362609 °	-122.360945 °	
DWR ID	DWR_NA0018_01_f _ 2012_9					
Action/Comments						
Thin trees to allow visibility of the ground and room to flood fight. Inspector Comments: Fish and Wildlife Service has not completed any maintenance.

Remove the small trees along the landside slope.

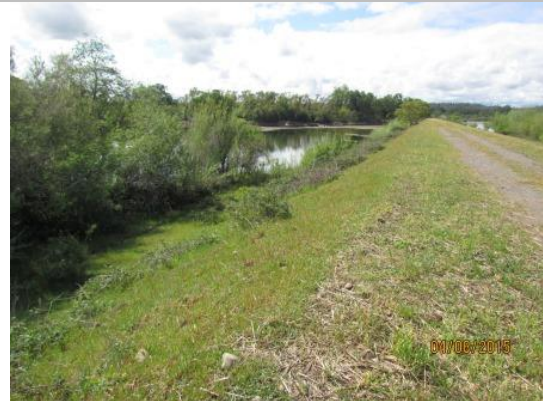
Photo 1 of 2 : FA_2015_NA0018_269_1_20150910_00001.jpg

LM Start	0.10	Rating **	M	Issue No.	1
LM End	0.30	Issue Type +	Ma	Location *	LS
Category	Earthen Levee			GPS Latitude/Longitude	
				Start	End
Item	Vegetation			40.511185 °	40.510670 °
				-122.360553 °	-122.361203 °
DWR ID	DWR_NA0018_01_s_2012_1				
Action/Comments					
Remove the wild growth other than native grasses from the levee slopes. Inspector Comments: Fish and Wildlife Service has not completed any maintenance.

View of the blackberries and other vegetation along the landside slope.

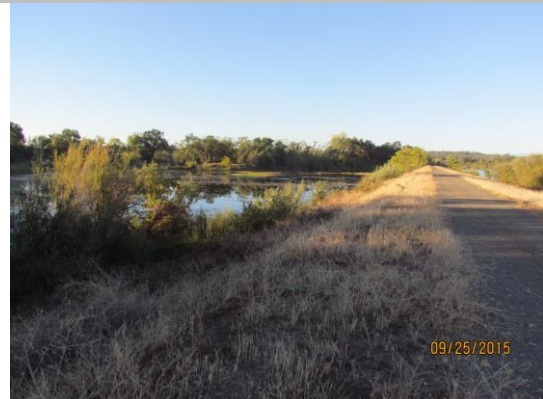
Photo 2 of 2 : FA_2015_NA0018_269_1_20151012_00008.jpg

LM Start	0.10	Rating **	M	Issue No.	1 (cont)
LM End	0.30	Issue Type +	Ma	Location *	LS

View of the blackberries and other vegetation along the landside slope.

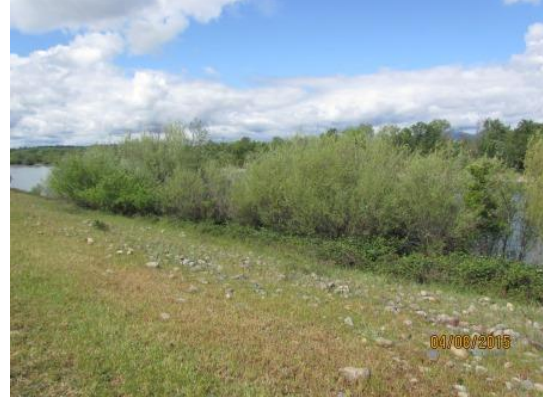
Photo 1 of 2 : FA_2015_NA0018_269_4_20150910_00003.jpg

LM Start	0.21	Rating **	M	Issue No.	4
LM End	0.26	Issue Type +	Ma	Location *	WS
Category	Earthen Levee			GPS Latitude/Longitude	
				Start	End
Item	Trim / Thin Trees			40.511518 °	40.508234 °
				-122.360100 °	-122.363430 °
DWR ID	DWR_NA0018_01_s _ 2012_4				
Action/Comments					
Trim and thin trees to allow visibility of the ground and room to flood fight.					
Inspector Comments: Trim the trees along the waterside slope.

Trim the trees along the waterside slope.

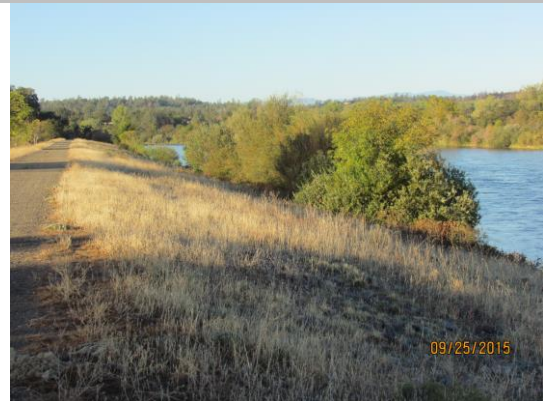
Photo 2 of 2 : FA_2015_NA0018_269_4_20151012_00009.jpg

LM Start	0.21	Rating **	M	Issue No.	4 (cont)
LM End	0.26	Issue Type +	Ma	Location *	WS

Trim the trees along the waterside slope.

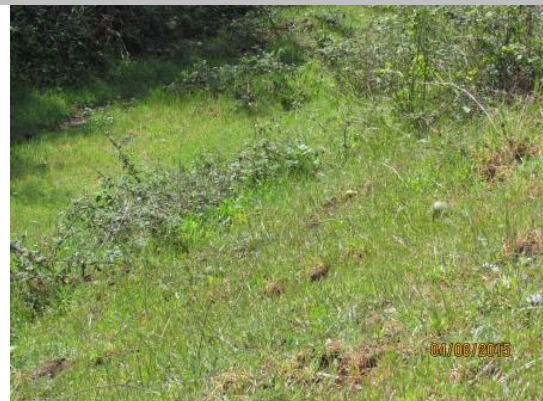
Photo 1 of 2 : FA_2015_NA0018_269_6_20150910_00004.jpg

LM Start	0.22	Rating **	M	Issue No.	6
LM End	0.30	Issue Type +	Ma	Location *	LS
Category	Earthen Levee			GPS Latitude/Longitude	
				Start	End
Item	Animal Control			40.510671 °	40.511185 °
				122.360944 °	122.360553 °
DWR ID	DWR_NA0018_01_s _ 2013_6				
Action/Comments					
Repair the levee slope damaged by livestock and prevent large animal access.					
Inspector Comments: The livestock damaged the L/S slope.

View of the livestock erosion along the landside slope.

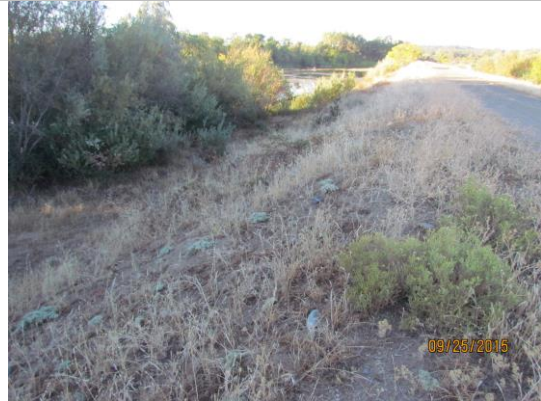
Photo 2 of 2 : FA_2015_NA0018_269_6_20151012_00010.jpg

LM Start	0.22	Rating **	M	Issue No.	6 (cont)	
LM End	0.30	Issue Type +	Ma	Location *	LS	
Category	Earthen Levee			GPS Latitude/Longitude		
				Start		End
Item	Animal Control			40.510671 °		40.511185 °
				122.360944 °		122.360553 °
DWR ID	DWR_NA0018_01_s _ 2013_6					
Action/Comments						
Repair the levee slope damaged by livestock and prevent large animal access.						
Inspector Comments: The livestock damaged the L/S slope.

View of the livestock erosion along the landside slope.
